ADVENTURE ISLAND LIGHTNING INCIDENT

**REPORT ON THE DEADLY FAILURE OF AN
EARLY STREAMER EMISSION LIGHTNING ROD
[Revision 1]**

**By
Z. A. Hartono & I Robiah
April 2012
E-mail: zahartono@iecc.org**

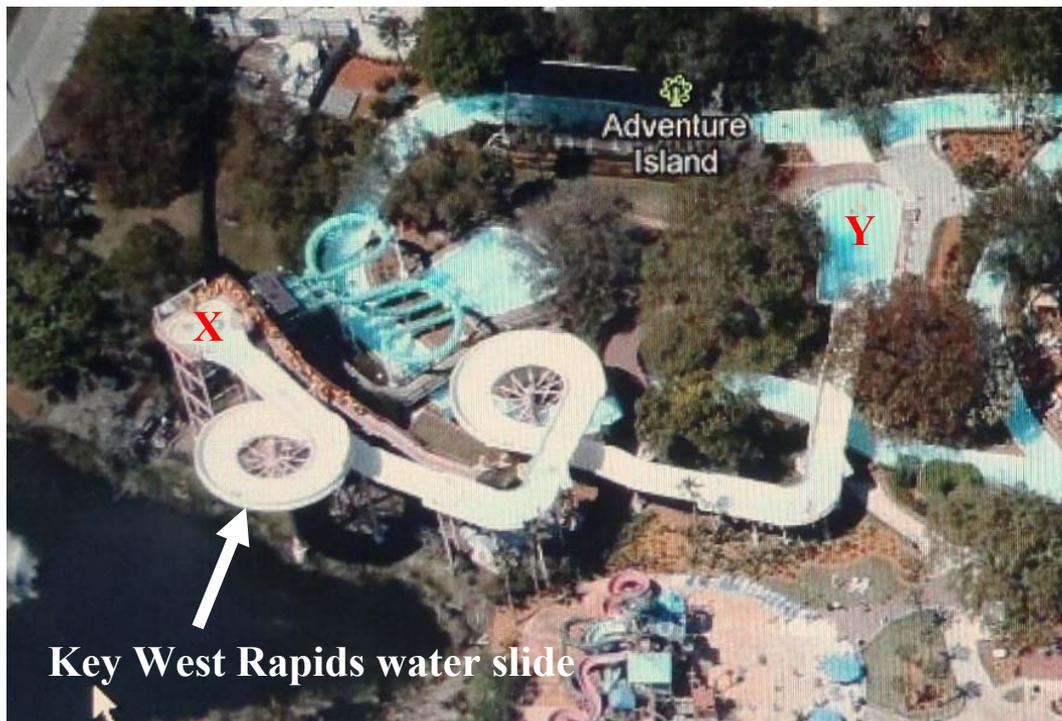
The Key West Rapids water slide (Fig. 1) is a six-story (high), 700 foot (long) slide with entry pools at the top (X) and bottom (Y).

Fig. 1: The Key West Rapids water slide. (Source: Google Map/Satellite view)

According to the news report, the lifeguard supervisor was helping the guests off the water slide when he was struck by lightning. However, the news report made no mention whether he was at the top (X) or bottom (Y) entry pool when the incident happened.

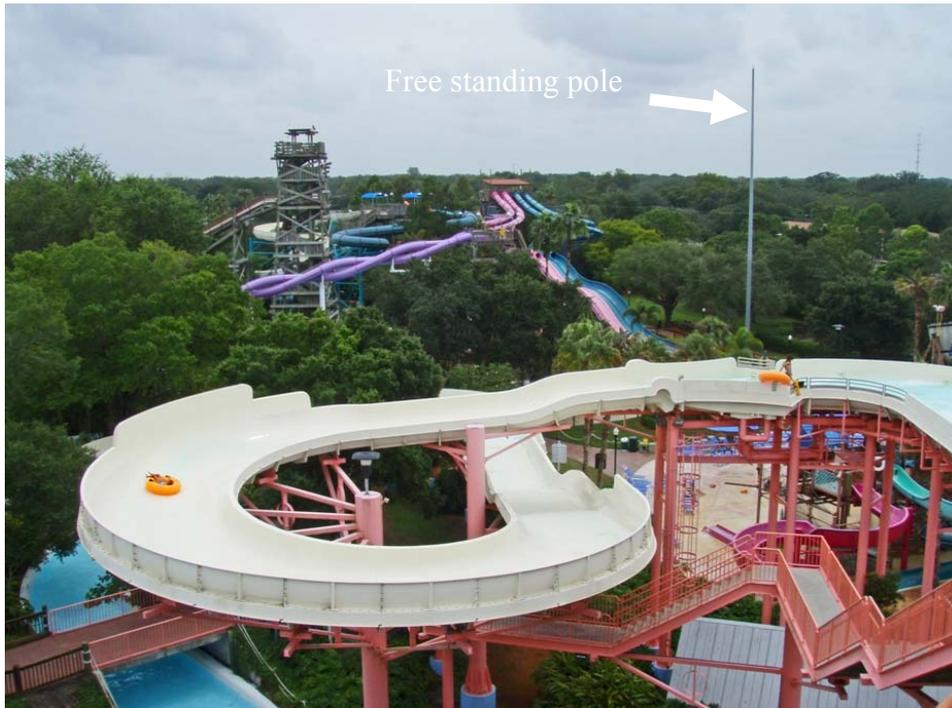
Using Google Map to scan the theme park, a photograph was found that shows a tall free standing pole near the water slide (Fig. 2). On closer inspection, a small device was found to have been installed on top of the pole which resembled a Prevelectron air terminal i.e. lightning rod (Fig. 3).

Fig. 2: View of the free standing pole from the water slide. (Source: Google Map)

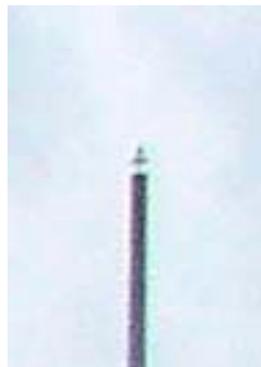
Fig. 3: Image of the Prevector air terminal at the top of the pole (left) and the Prevector air terminal (right/Source: Indelec).

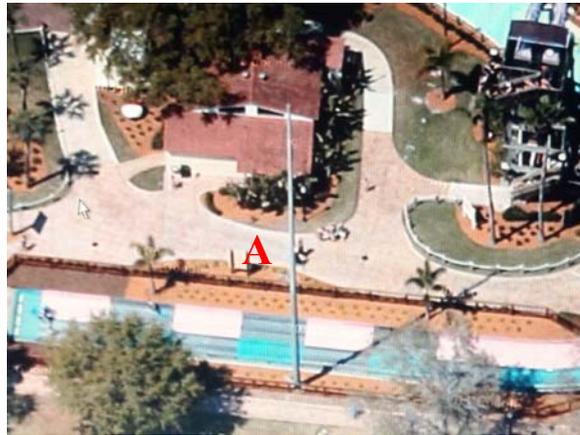
By using the Google Map facilities (eg. Satellite and Street views), the approximately 20 m tall free standing pole shown in the photograph was located at position A (Fig. 5). A similar pole was also identified and located at position B (Fig. 6). With the exact locations of the two pole-mounted Prectron air terminals known, it is possible to determine whether the water slide is within the claimed ESE protection zones.

Fig. 5: The Prectron air terminal location at A.

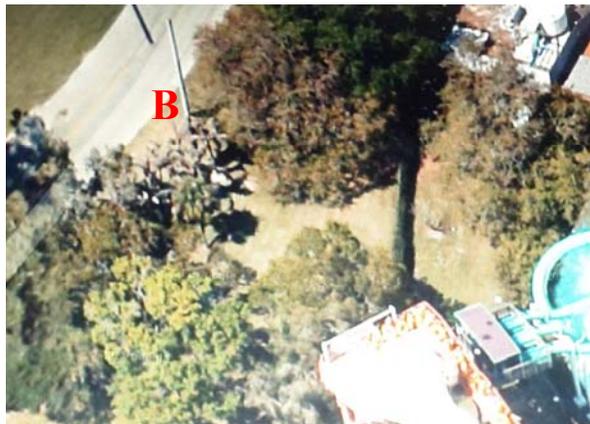
Fig. 6: The Prectron air terminal location at B.

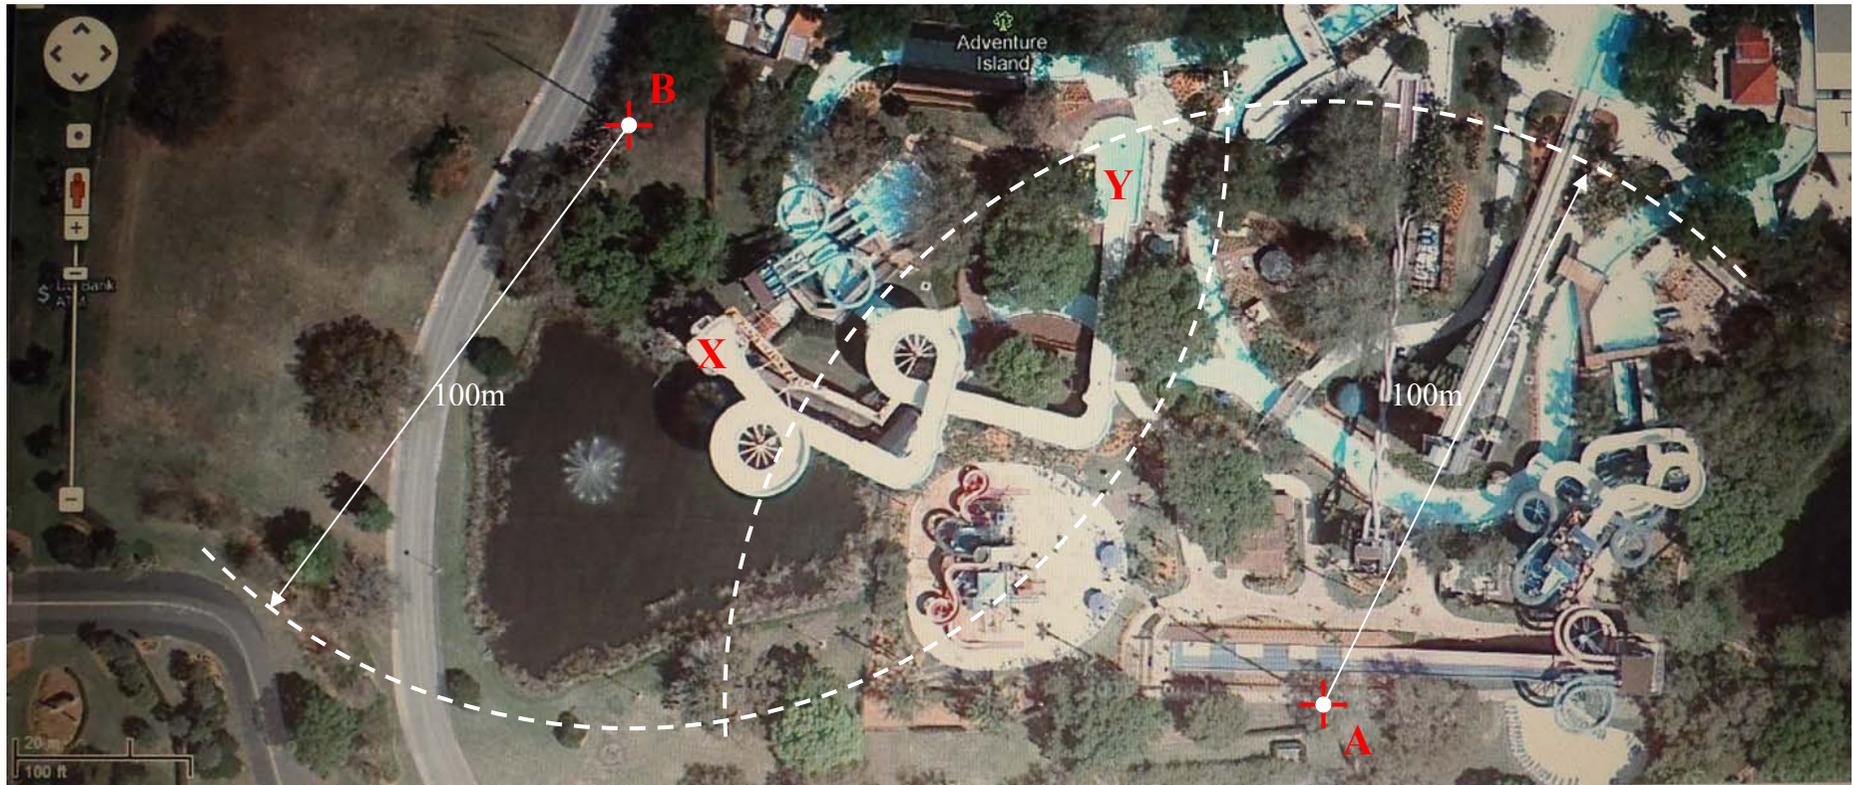
Using the distance scale provided by Google Map, it was found that both entry pools X and Y were located within the claimed ESE protection zone (Fig. 7). The upper entry pool X was located within 50 m of the Prectron air terminal at location B while the lower entry pool Y was located within 100 m of both Prectron air terminals at locations A and B.

Since the victim was reportedly struck by lightning while he was on duty on one of the two entry pools, this incident provides firm evidence that the actual ESE protection zone is very much smaller than is claimed.

Fig. 7: The positions of the entry pools X and Y in relation to the Preactron air terminals A and B. (Source: Google Map satellite view)

In order to avoid further lightning casualties, it is highly recommended that theme parks be installed with NFPA780 compliant lightning protection systems and implement proven lightning safety rules.

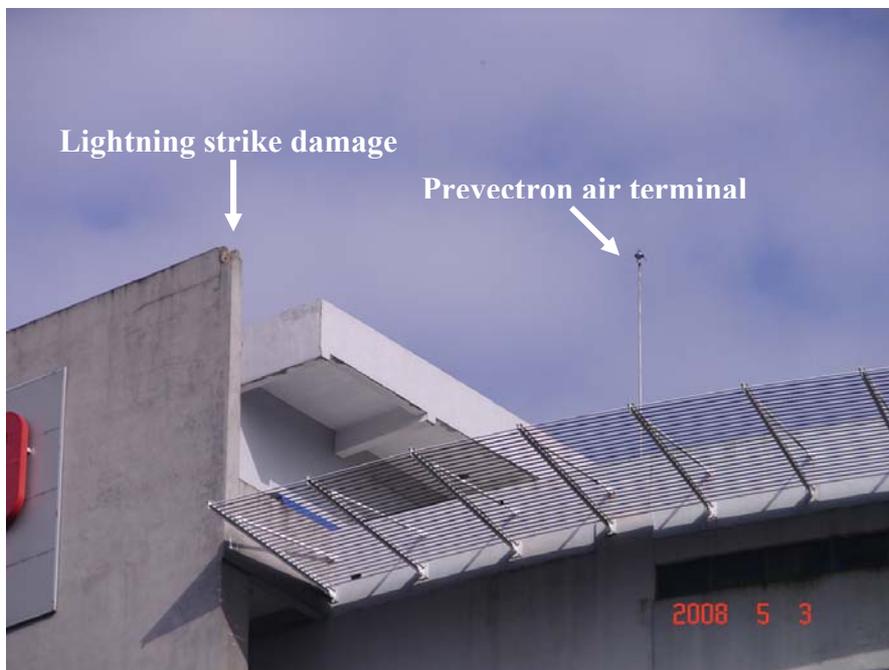
Hence, it is not surprising that the unfortunate victim in this incident was struck within the claimed protection zone of one or both ESE lightning rods. In fact, the failure of the Prevector ESE lightning rod has been observed in a number of cases in Malaysia. One of them was mentioned in the above paper and is shown below (Fig. 8).

Fig. 8: The lightning struck TNB building in Johor Baru, Malaysia.
