**FIRE
AND
MATERIALS
2005**

LIGHTNING INDUCED CSST FIRES

Mark Goodson PE*
Mark Hergenrether MSME*
Goodson Engineering, USA

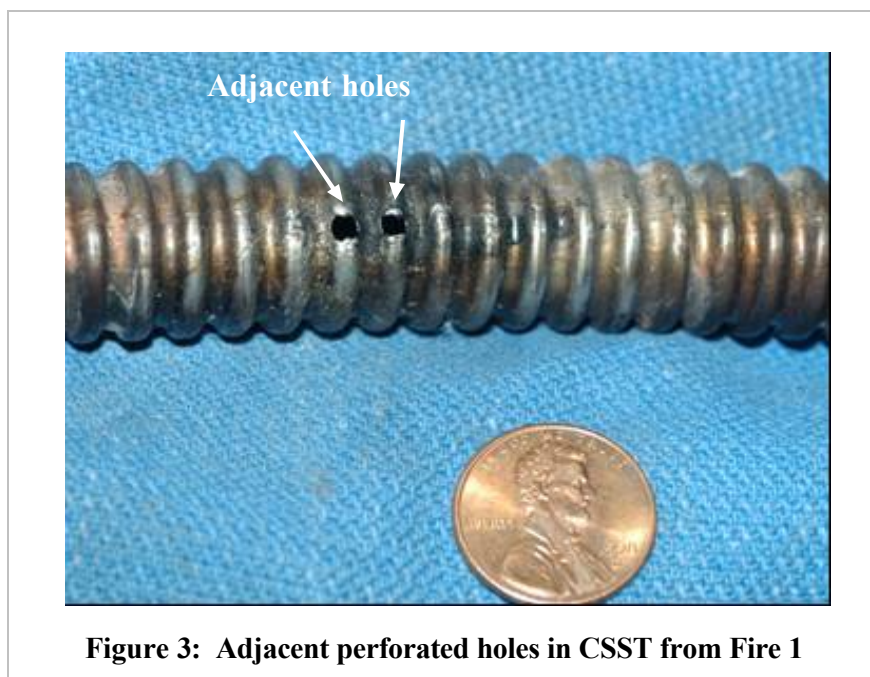
The fire occurred in the wood framed chimney space that had a metal chimney insert. CSST ran through the chimney space to feed the gas igniter. Four perforations were found in the CSST, ranging in size from a pinhole to a hole about 125 mils along its major axis. A STRIKE FAX lightning report showed that 4 hits within 0.1 mile of the house were recorded¹¹. Figure 3 shows 2 adjacent holes that were created in the CSST.

Figure 3: Adjacent perforated holes in CSST from Fire 1

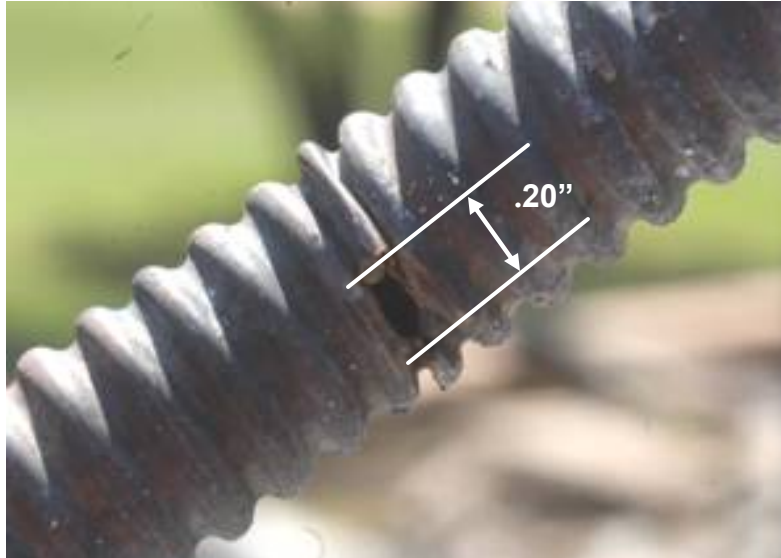
The fire occurred in an expensive house (construction not finished) with a value in excess of 6 figures. The house was a 2 story house, and plumbed with approximately 95% black pipe. Two runs of CSST, each serving a fireplace, comprised the CSST piping in the house. A perforation with its major axis measuring approximately 200 mils was found in one run of the CSST (Figure 4). An interview with a neighbor confirmed that the audible and visual components of the strike were sensed simultaneously. A positive lightning report was obtained, showing 11 strikes within 0.5 mile. Regrettably, the house was razed before the investigation was complete. Figure 5 shows the failed CSST run to the fireplace.

Figure 4: Perforated CSST pipe from Fire 2

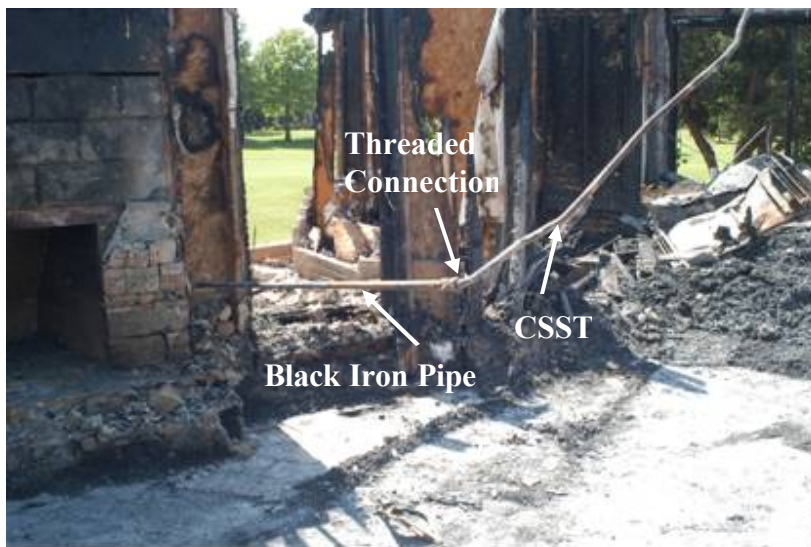
Figure 5: CSST tied to Black Iron pipe from fireplace

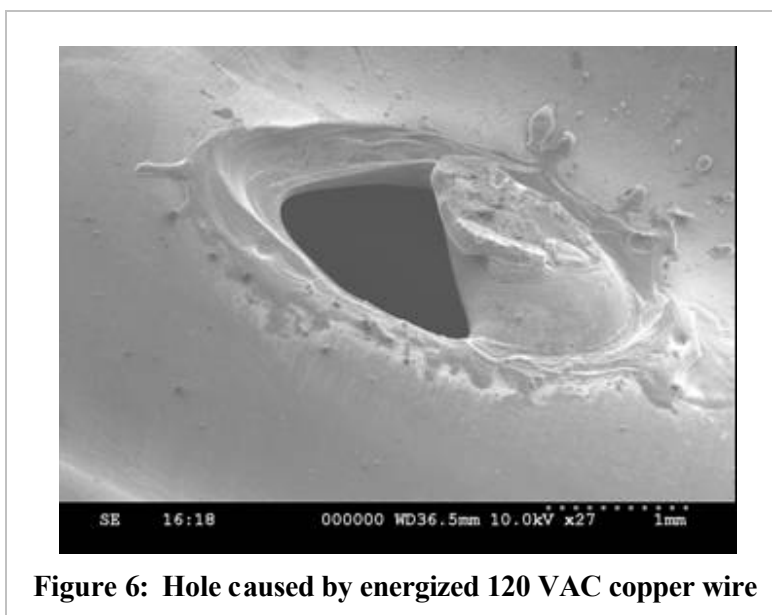
Investigation of a fire caused by CSST and lightning is a straight forward process. One of the characteristics of CSST that makes this a simple investigation is the high melting point. Stainless steel is not prone to melt during a fire. If a hole is found in CSST, there is a good chance that the hole is from electrical current. One would need to reasonably eliminate other sources of the leak, to include eutectic melting (alloying) and mechanical damage. Microscopic work would be necessary to insure that the orifice was created by an arcing condition. As with copper wire, one is looking for sharp delineations between fused and non-fused areas. If there appear to be other metals present at the arc site, one should conduct EDX (Energy Dispersive XRay) to see if the metal being examined is stainless, or if it has other metals present (such as Cu, Zn, Al, Sn). If copper is present, one might reasonably attribute the problem to an ongoing fire attacking both the CSST and nearby NM electrical wiring – when the NM faulted to the CSST, a perforation was created. Figure 6 shows a photo taken under a scanning electron microscope (SEM) of a section of CSST that failed when touched by an energized 120 VAC copper wire.

Figure 6: Hole caused by energized 120 VAC copper wire

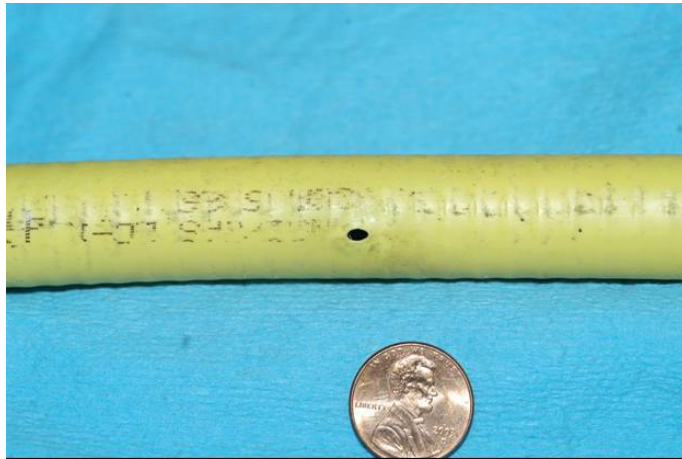
To find holes, we recommend an instrumented leak test at ~ 7" WC air. One end of the CSST should be plugged, and each hole sequentially plugged (modeling clay seems to work the best) until the CSST no longer leaks. One of the holes we found in CSST was in an area of tubing where the polymer coating had no pyrolysis (See Figure 7). Also, Figure 8 is a microscopic view of this small leak. As in any fire investigation, the leaks and subsequent flame development must support the area of origin, or the leaks would appear to be of little consequence.

Figure 7: Photo of perforated CSST without pyrolysis

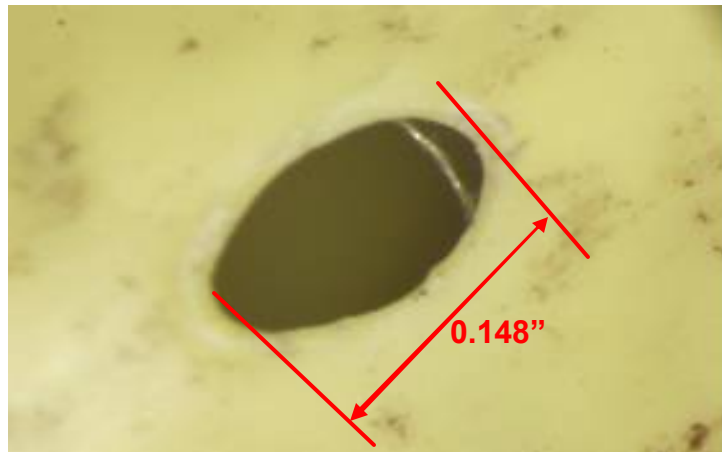
Figure 8: Microscopic View of Perforated CSST

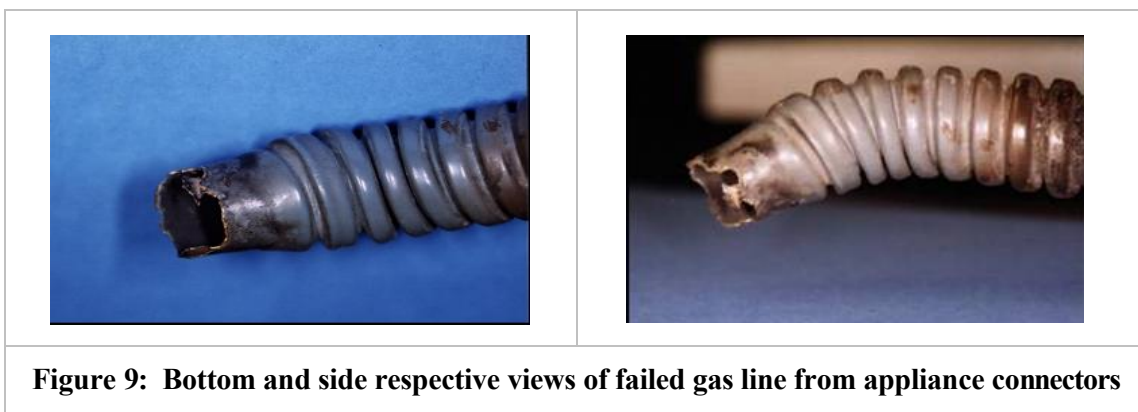
The Frisco Fire Department Report lists escaping gas from the end connectors during lightning events as also being possible sources of ignition²⁶. In a previous article written by one of the authors (MEG), this very phenomenon was described on appliance connectors²⁷. The fact that a gas line fails at a connection is no surprise, in that gas lines are chosen for mechanical integrity at their junctions, and not necessarily electrical conductivity. Figure 9 shows the end of a failed appliance connector that has arced and caused a fire due to electrical current flow. We might expect to see similar manifestations with CSST at its connectors.
