A Long Term Study on the Performance of Early Streamer Emission Air Terminals in a High Keraunic Region

Z. A. Hartono and I. Robiah

Lightning Research Pte. Ltd.
Mail: 457 Jalan B11, Taman Melawati
53100 Kuala Lumpur, Malaysia
E-mail: zahartono@ieee.org, robiah@ieee.org

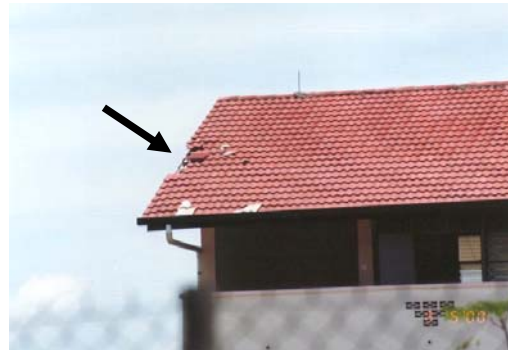
These buildings have been installed with the conventional system but the Franklin air terminals and conductors were not positioned at the known high risk locations i.e. at the ridge ends and edges of the gable roof.

As expected, the stricken points occurred at the predicted locations (Figures 9 and 10). The failure of

Figure 10: Photograph of a stricken point on the slanting edge of the gable roof. The air terminal conductor should also be installed on the edges of the gable roof.
