## **Conventional and Un-conventional Lightning Air Terminals: An Overview**

*Hartono Zainal Abidin, BSc (Elect), MIEEE*

### **Synopsis**

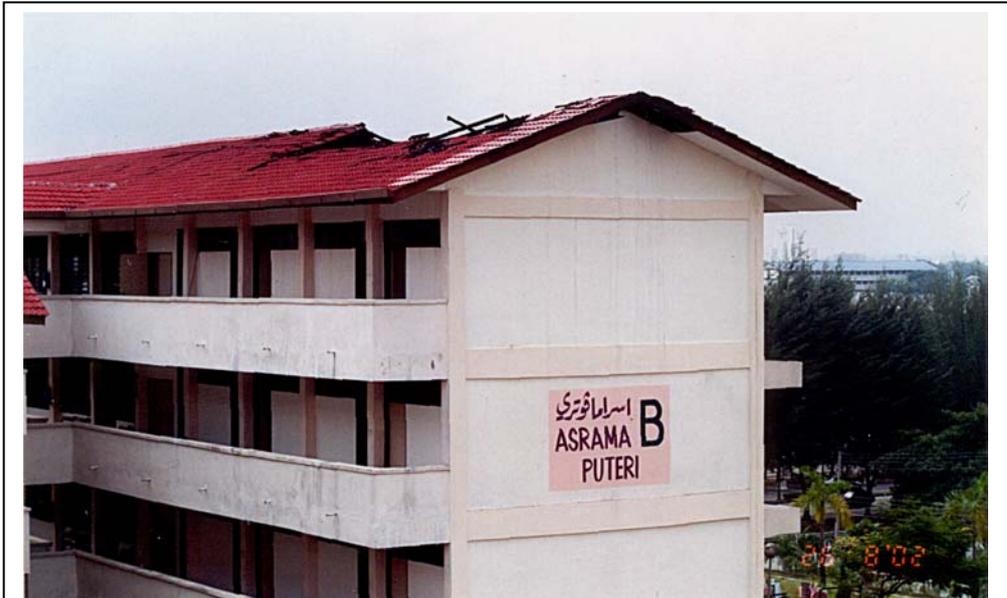
An external view of the lightning damaged hostel of the religious school in Subang Jaya. If the lightning had struck on an occupied dormitory room a few hours later, the possibility of injuries (and even deaths) among the students could not be avoided.

In addition to this loss, human lives have been put at risk when the building installed with the non-standard LPS had been struck and damaged by lightning. A clear example of this risk is the school hostel in Subang Jaya that was struck and severely damaged by lightning in August 2002.

The incident at the school in Subang Jaya in August 2002 is proof that the un-conventional air terminal is unproven. More incidences of this kind can be expected in the future and may probably cause more losses than just a fire.

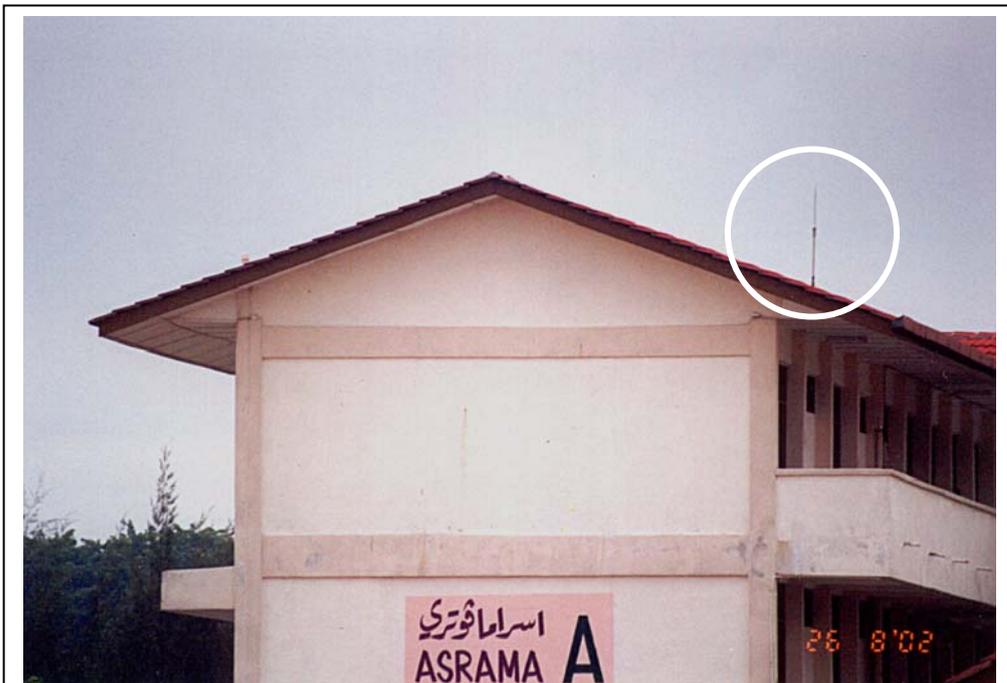
A French-made ESE air terminal (circled) was installed on the roof of the adjacent building (Asrama A) which is about 20m from the lightning strike damage. According to the vendor's product description, this device provides coverage of about 50m radius i.e. to "protect" both blocks A and B. This failure is just another example that the sophisticated lightning protection system does not work.

The Subang Jaya school complex of about half a dozen buildings was installed with three lightning attracting air terminals that is claimed to have protection coverage of about 50 m

each. The lightning strike and resultant fire shows a serious breach of safety had occurred which have a potential to cause injury and loss of life.

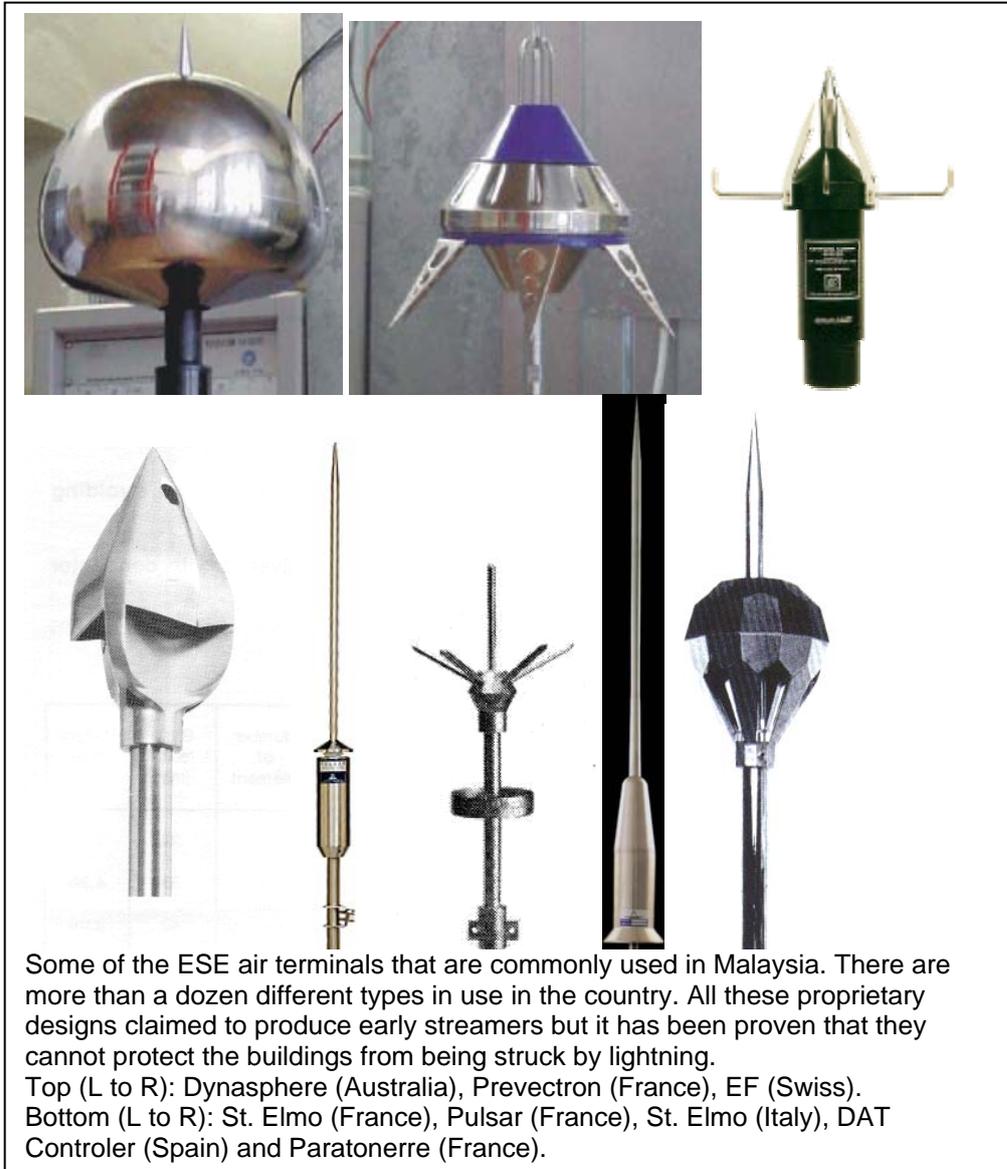
photographic studies<sup>7</sup> have shown that the ESE air terminals failed to protect many buildings from being struck by lightning.

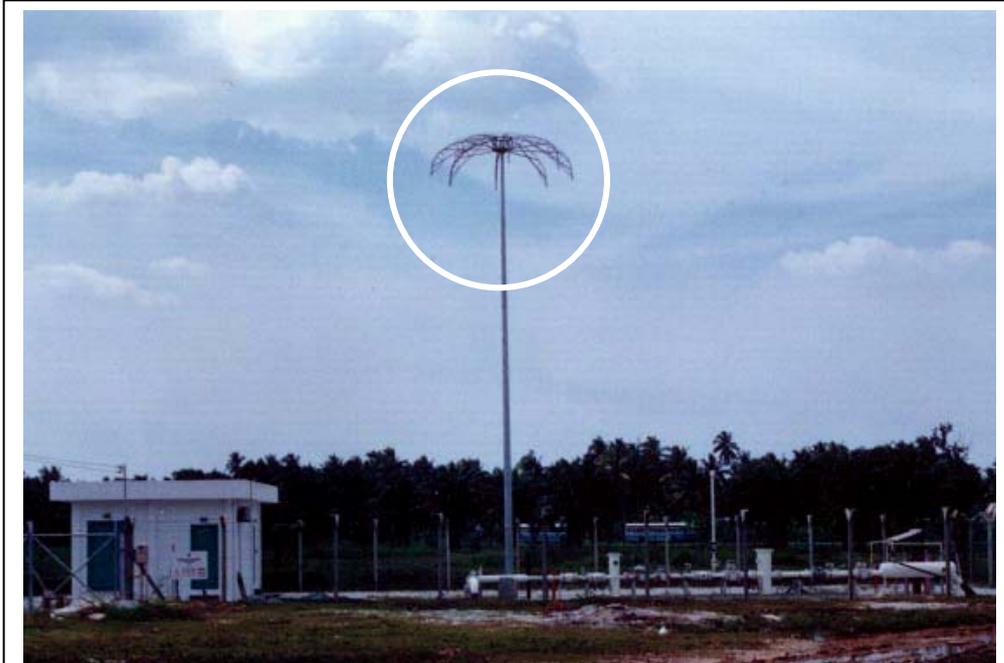
A DAS air terminal (circled) installed at a petroleum gas pumping station in Kapar. Similar installations in the USA have been struck by lightning and have been reported in several scientific papers.

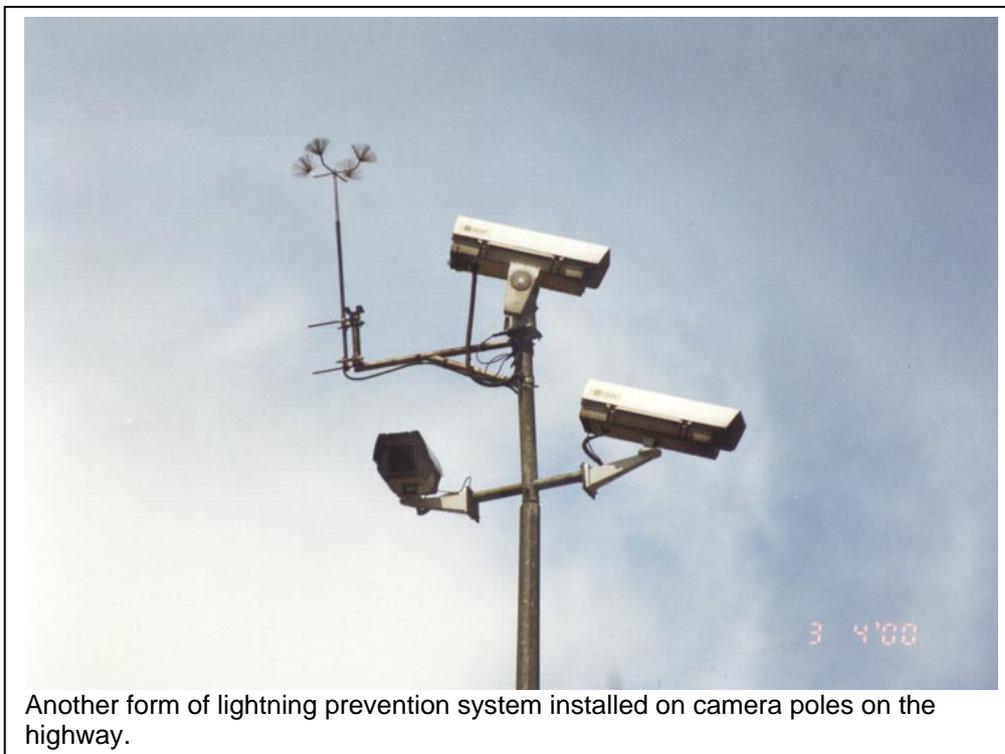
Besides the DAS, other lightning prevention air terminals have also been brought into the country in recent years due. They are very much smaller in size and in various shapes. However, they still made similar claims as that of the DAS.

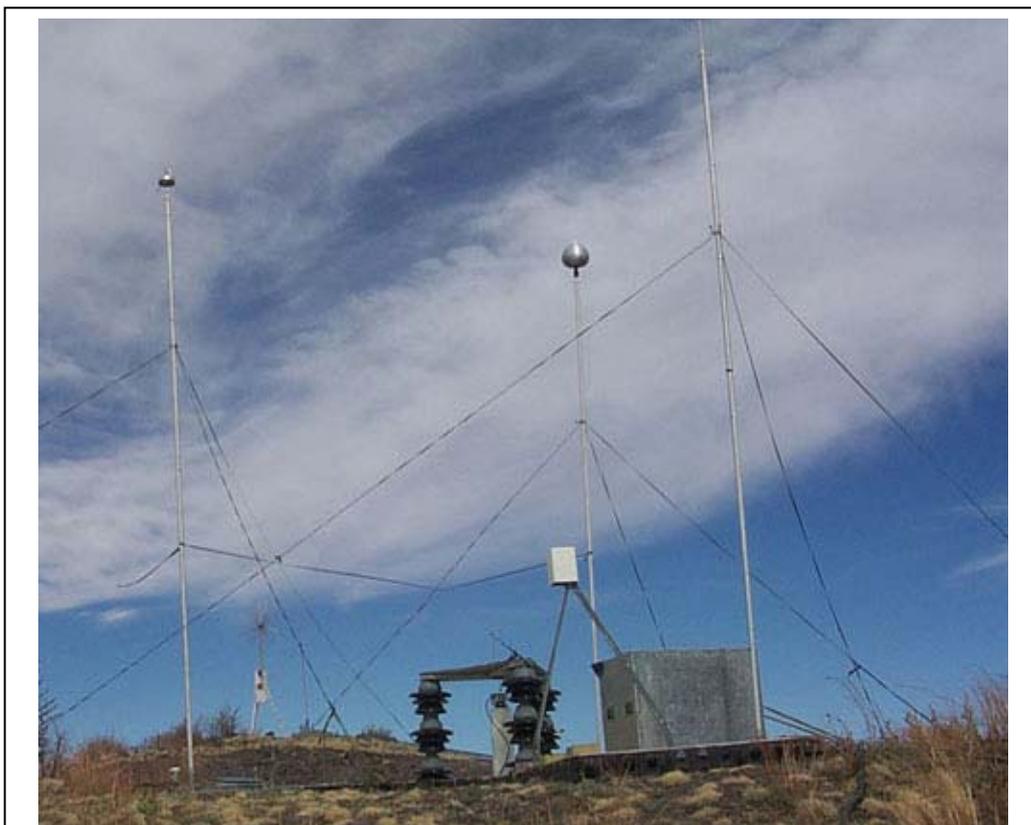
This picture shows of one of the New Mexico test sites where several types of ESE (French and Australian air terminals) and conventional air terminals had been exposed to lightning for several years to gauge their effectiveness under natural lightning conditions.

This independent study suggests that the ESE air terminals tested did not have the ability to attract lightning as claimed by their manufacturers. However, the ESE sales engineer would ignore all their earlier studies and refer only to the “on-going research” in order to dupe the unsuspecting customer.

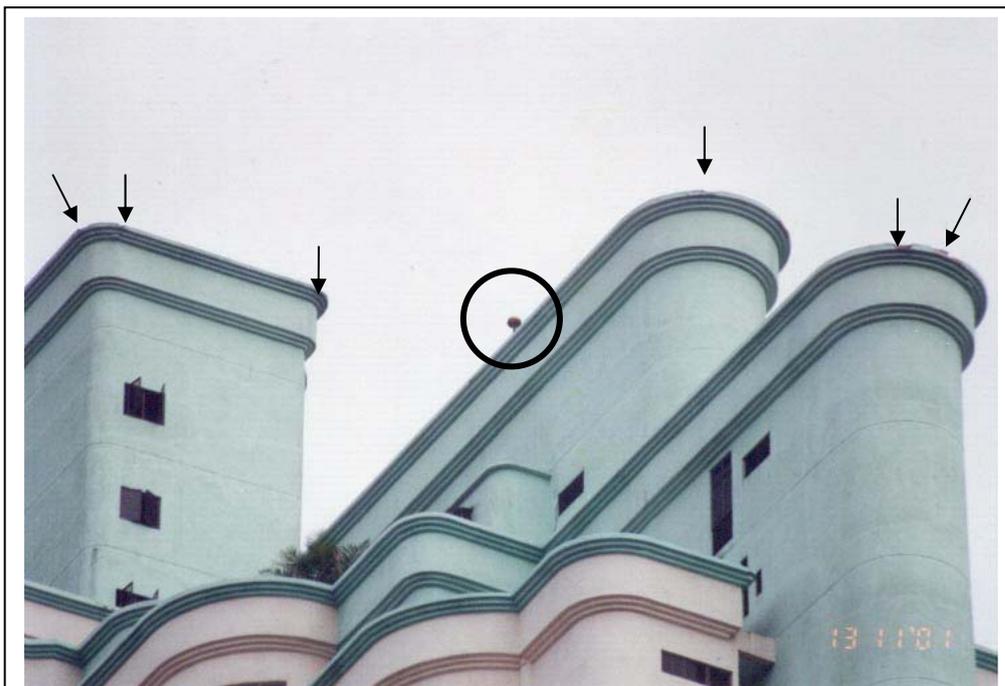
The Villa Putri apartment building in Kuala Lumpur was damaged (arrowed) by lightning at 7 different places on the roof. In spite of this building being a subject in a conference paper in 2000, the sales engineer still informed the building manager in 2002 that the building was free from lightning strike damages. One of the two Australian ESE air terminals can be seen above (circled).

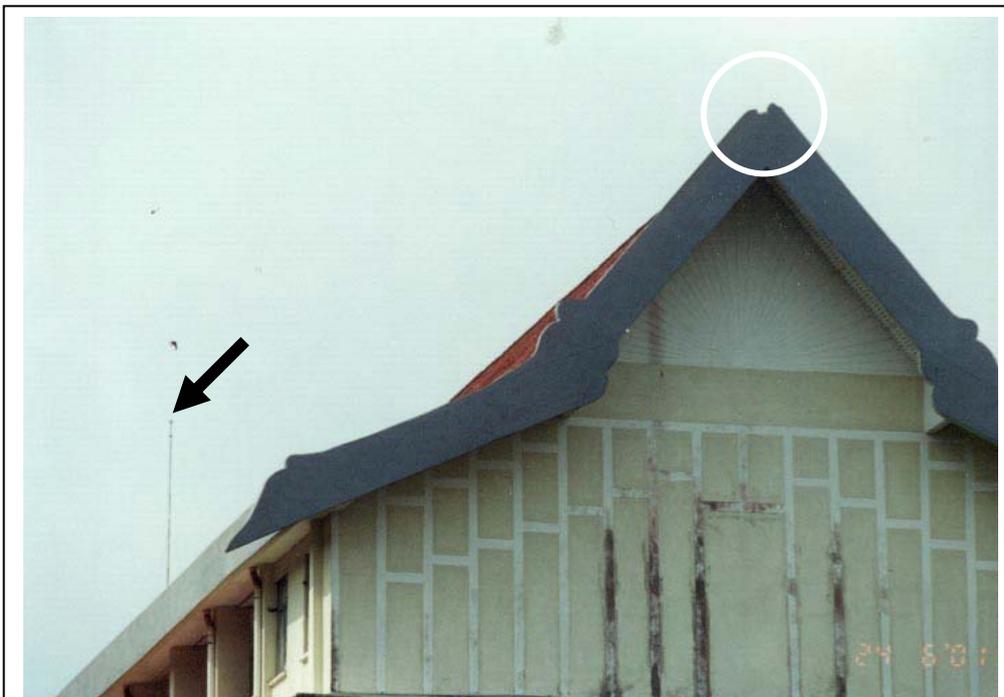
One of the UTM buildings in Skudai that had its façade damaged (circled) by lightning. An undamaged façade would have a sharp pointed apex. Several other similar buildings had been struck also with the damage in varying sizes. Most of the faculty buildings were installed with the ESE air terminals (arrowed).

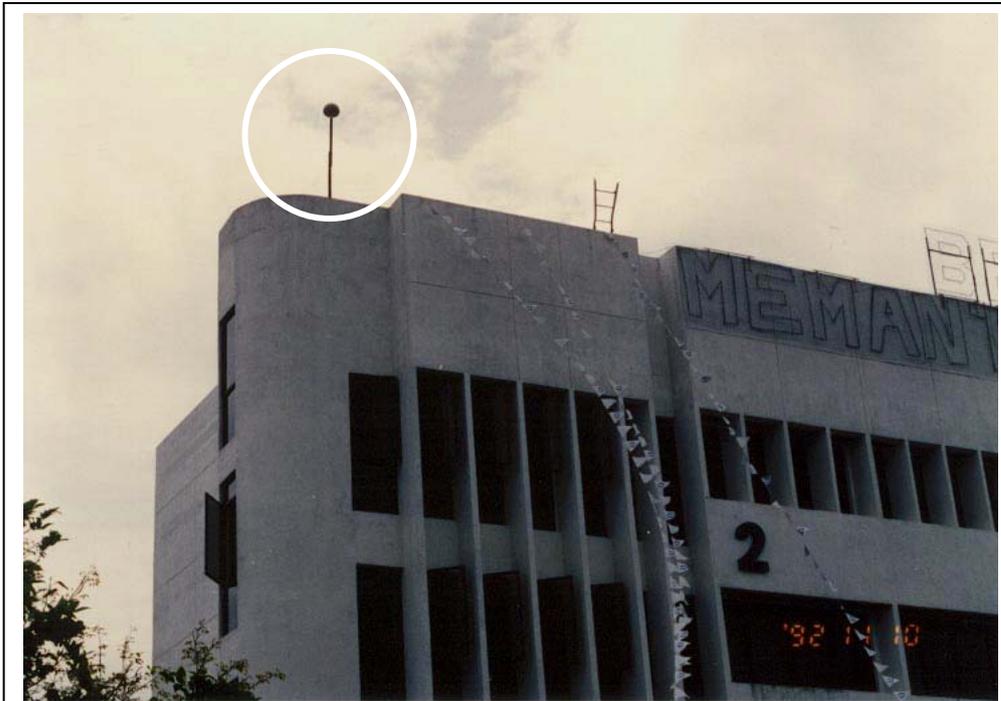
An ESE air terminal (circled) installed on Building #2 of the SIRIM complex in 1992. Another type of ESE air terminal had also been installed on Building #3.

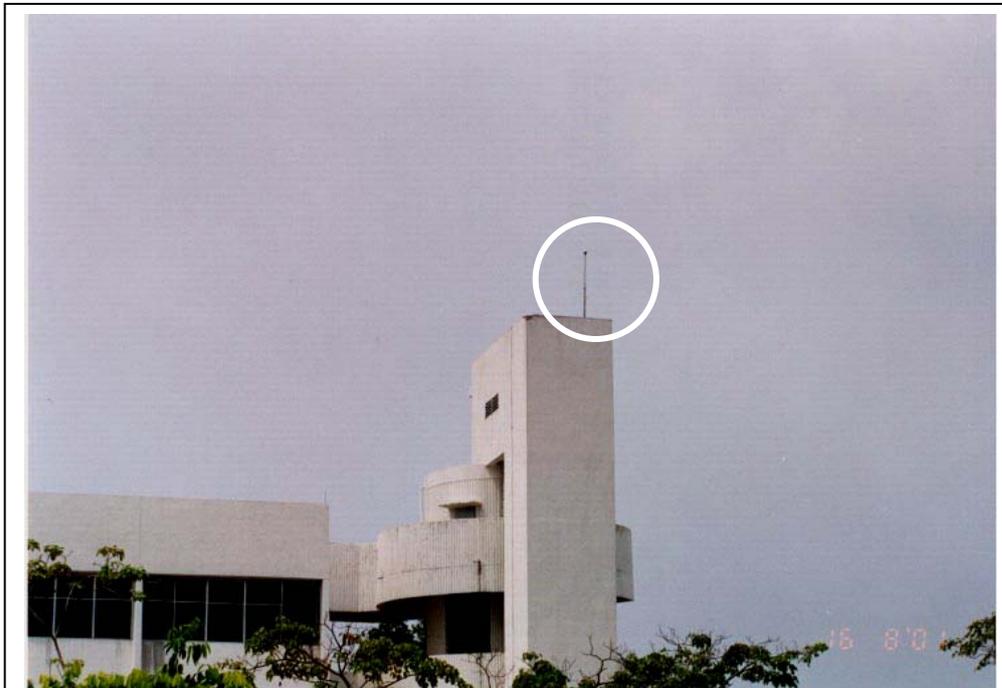
The SIRIM Block #8 with the ESE air terminal (circled) that was installed between January and August 2001. SIRIM still continued to install the ESE air terminals even though the ESE technology had just been dropped from the new Malaysian standard.
