ADVENTURE ISLAND LIGHTNING INCIDENT

**REPORT ON THE DEADLY FAILURE OF AN
EARLY STREAMER EMISSION LIGHTNING ROD
[Revision 1]**

**By
Z. A. Hartono & I Robiah
April 2012
E-mail: zahartono@iecc.org**

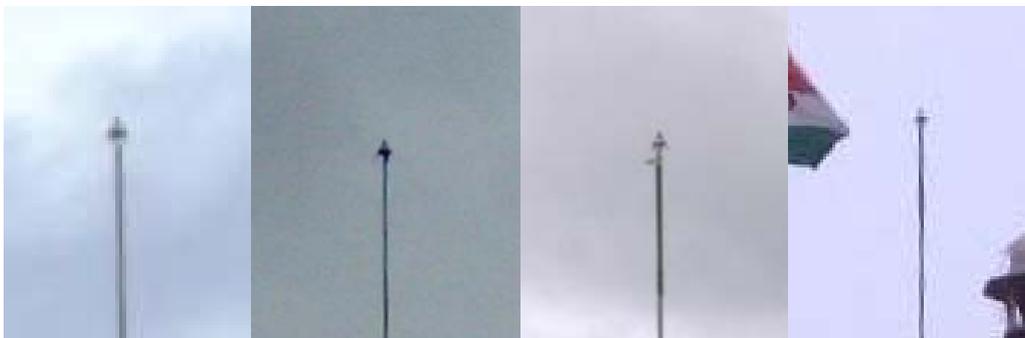
In order to confirm that the device is a Prevelectron air terminal, its shape and shade is compared with similar photographs of other Prevelectron air terminals available on-line. Several photographs of the Prevelectron air terminals were found on the Indelec India website which closely resembled the one photographed at the theme park (Fig. 4).

Fig. 4: Images of Prevector air terminals taken from (l. to r.) E&L factory (Ahmadabad), Bali Bridge (Kolkata), Mangalore Airport (Mangalore) and Red Fort (Delhi), India. (Source: Indelec India / http://www.indelecindia.com/indian_reference.php)
